LNVA Repairs Jones Crossing at the Devers Canal

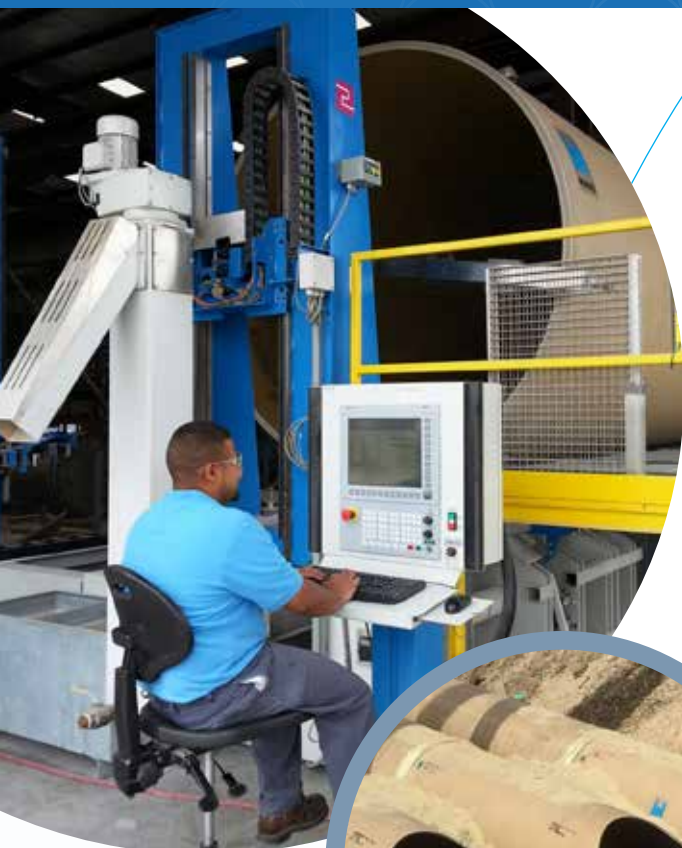
This fully automated cutter not only produces perfectly cut pipes, but does so quickly and in a more environmentally friendly manner. Since cutting is done in a wet environment, no dust is generated.

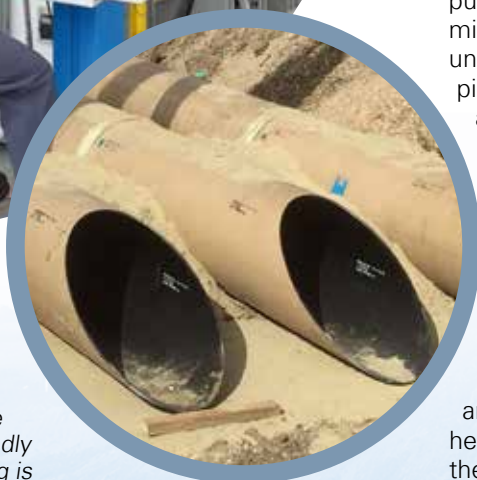
Hobas Pipe USA supplied 600 feet of 48-inch pipe to the Lower Neches Valley Authority. LNVA crews installed the pipe relatively easily with no previous experience installing this type of pipe.
