# LNVA Repairs Jones Crossing at the Devers Canal

THE LOWER NECHES VALLEY AUTHORITY (LNVA) is one of the 23 River Authorities created by the State of Texas to develop and manage the waters of the State. The LNVA is responsible for fresh water management in far southeastern Texas in the entirety of Jefferson, Hardin, and Tyler Counties, and portions of Liberty and Chambers Counties. The watersheds of the Neches River and its tributaries occupy an area of approximately 10,000 square miles. The area receives generous amounts of rainfall, producing stream flows in the Neches and its tributaries of around 4,323,000 acre-feet of water a year at Port Arthur, Texas, where it empties into Sabine Lake, and ultimately into the Gulf of Mexico.

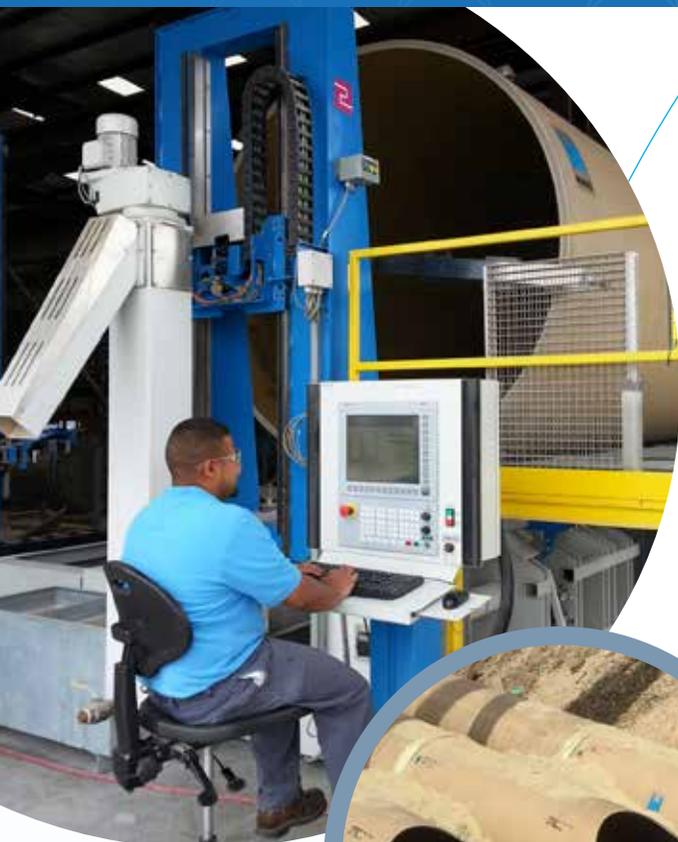
*This fully automated cutter not only produces perfectly cut pipes, but does so quickly and in a more environmentally friendly manner. Since cutting is done in a wet environment, no dust is generated.*

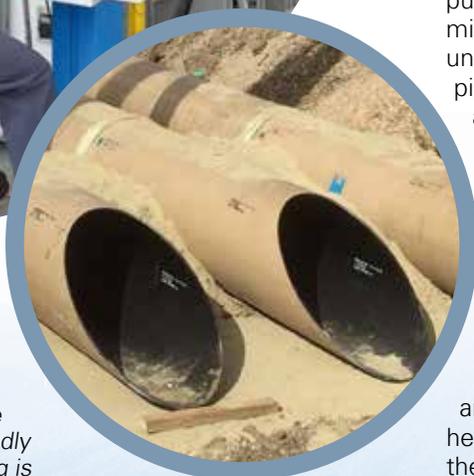
*Hobas Pipe USA supplied 600 feet of 48-inch pipe to the Lower Neches Valley Authority. LNVA crews installed the pipe relatively easily with no previous experience installing this type of pipe.*
