# LNVA Repairs Jones Crossing at the Devers Canal

THE LOWER NECHES VALLEY AUTHORITY (LNVA) is one of the 23 River Authorities created by the State of Texas to develop and manage the waters of the State. The LNVA is responsible for fresh water management in far southeastern Texas in the entirety of Jefferson, Hardin, and Tyler Counties, and portions of Liberty and Chambers Counties. The watersheds of the Neches River and its tributaries occupy an area of approximately 10,000 square miles. The area receives generous amounts of rainfall, producing stream flows in the Neches and its tributaries of around 4,323,000 acre-feet of water a year at Port Arthur, Texas, where it empties into Sabine Lake, and ultimately into the Gulf of Mexico.

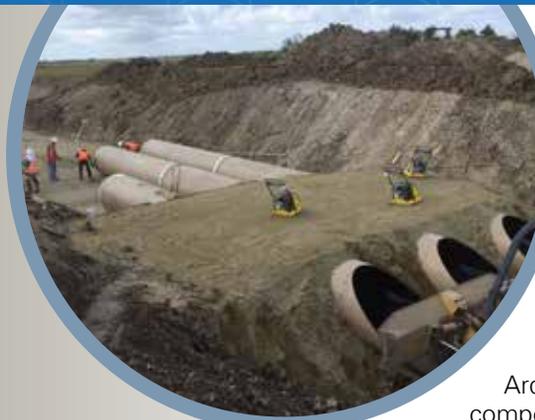
"We were experiencing problems with the existing reinforced concrete pipe joints separating and allowing canal water to leak into the ditch," said Ryan Ard, P.E., Inva engineering manager. "LNVA made several repairs over time to patch any leaks that appeared. Over the years, erosion and weathering had deteriorated the original timber headwalls in the drainage ditch.

This ongoing erosion exacerbated by the heavy rains in early 2015 and again in early 2016 eventually infiltrated and undermined the headwalls, allowing the banks of the drainage ditch to creep toward the canal. Had we allowed the problem to persist, the canal banks would have ultimately been breached by erosion, thereby allowing canal water to spill into the drainage ditch below."

The installation of the three 160-foot runs in the drainage ditch took four days, while installation of the three 40-foot runs in the canal under the roadway was completed in only one day. Once the new Hobas pipe was installed, LNVA crews re-graded the drainage ditch slopes and reconstructed the canal banks and rock road back to their pre-existing grades. Because repairs to the roadway and canal system were performed in the agricultural off-season, the road was closed for duration of construction, as no residences or local traffic were affected.

The scope of the repair would include excavating and removing the existing drainage ditch and canal crossings. The drainage ditch and canal both included three runs of 48-inch reinforced concrete pipe. The pipe in the ditch measured approximately 160-feet and the pipe in the canal was approximately 40-feet long. The total depth of the drainage ditch was approximately 12 feet.
