Naches-Selah Irrigation District Upgrades System

The existing wood stave flumes were replaced with 96-inch inverted siphons made of Hobas Pipe.

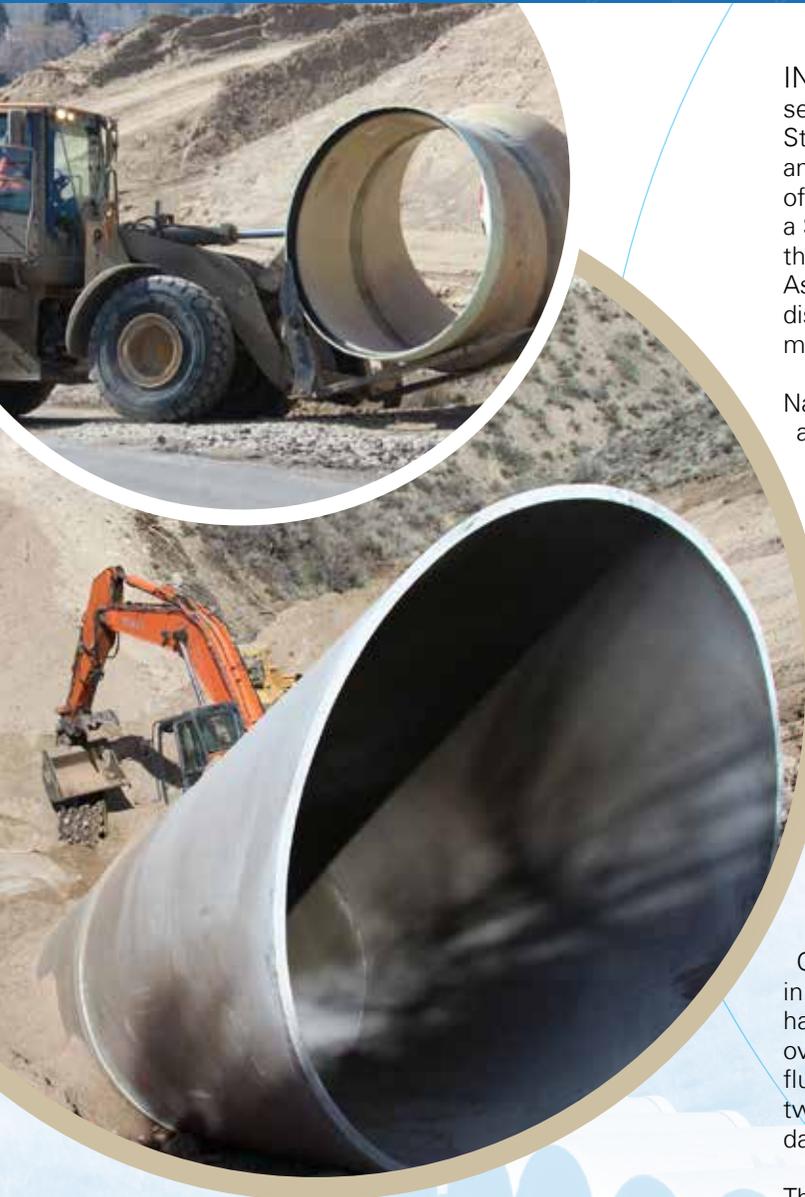
Custom fittings were manufactured of the same material as the CCFRPM pipe to meet the design requirements.

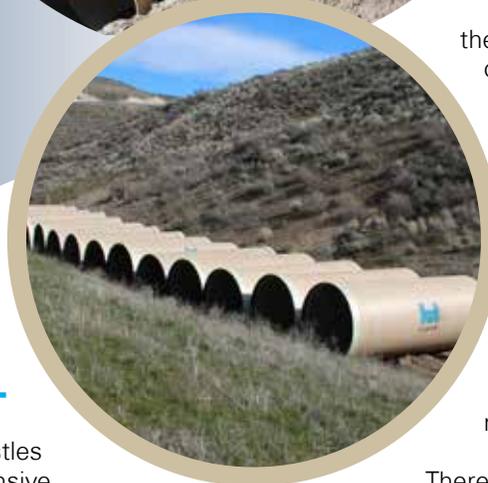
Ease of installation allowed Tapani, Inc. to meet the project schedule in time for the start of the 2015 watering season.
